## Case Study – LNER Neville Hill Crash

**By Roger Ford – Modern Railways, January 2021** - In Rudyard Kipling’s poem ‘M’Andrews hymn’, an old Scots ship’s Chief Fleet Engineer approaching retirement looks back on a long career. His reveries include the developments in propulsion machinery – Kipling knew his engineering – and concludes:

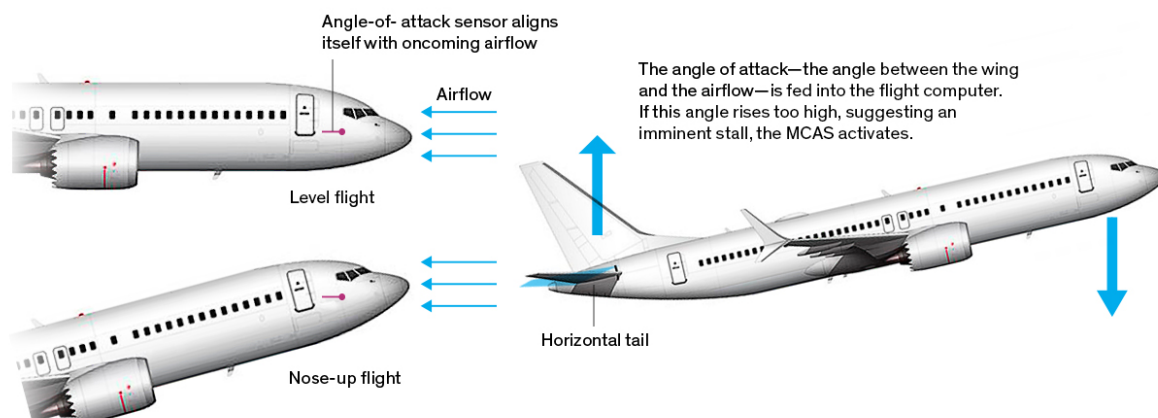
#### How the new Max flight-control system (MCAS) operates to prevent a stall

More recently, there were the two Boeing 737MAX accidents, where the magic included a facility which Boeing thought the pilots didn’t need to know about. To overcome different aerodynamic characteristics resulting from the bigger engines fitted to the MAX iteration of the 737, the flight control software included a programme which trimmed the aircraft nose down if the angle of attack, the degree of nose-up attitude in a climb, exceeded a pre-set amount. This was the Manoeuvring Characteristics Augmentation System, or MCAS. A faulty Angle of Attack (AoA) indicator exaggerated the climb angle and the MCAS responded by pushing down the nose. The pilots manually pulled the nose up, only for MCAS to push it down again.

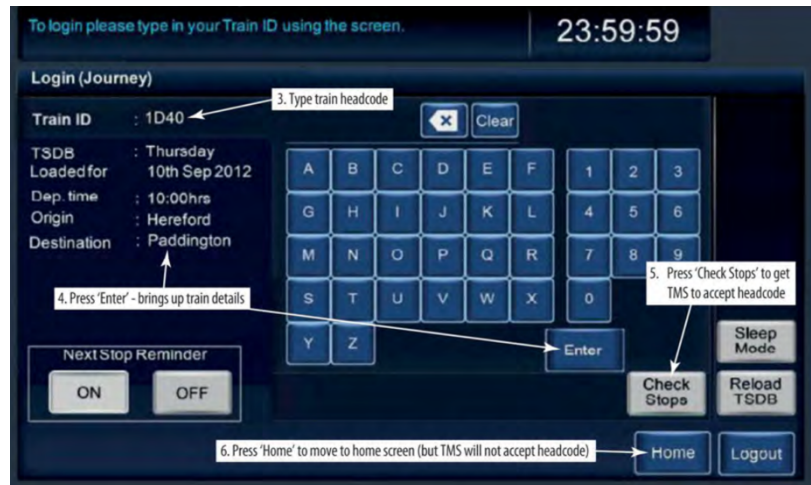
**FIGURE 3: TMS HEADCODE SCREEN**

Having entered the new head code on the TMS screen (Figure 3), the driver appears to have a choice. Either use the 'CHECK STOPS' button, to see the stopping pattern associated with the service he has just inserted, or use the 'HOME' button to complete the change and return to the home screen. Since this was an ECS working into the depot, there was no need to check stops and the driver pressed the 'HOME' button. Only to find that the original headcode was still displayed.

LNER had trained its drivers that pressing CHECK STOPS would allow a driver to check the station stops for the journey ahead. The driver operating instructions identified this as a step in the cab setup process. But drivers were also told that pressing HOME on the headcode screen would take the TMS to the home screen with the headcode having been accepted. However, reveals RAIB, LNER did not understand that CHECK STOPS had to be pressed first for the headcode to be accepted.

RAIB reviewed both documents and concluded that neither ‘clearly conveys the message that CHECK STOPS has to be pressed on the headcode screen for the TMS to accept the headcode’. It adds that the Hitachi documentation ‘was ambiguous in this regard’.

I’m sure that readers will have grappled with ambiguous procedures, buttons and sequences when setting up computers and smartphones. But this was a real lulu. As you can see from Figure 3, CHECK STOPS looks like an option. But if it was an essential action when resetting the headcode, there should have been a NEXT button which would take you to the CHECK STOPS screen, which would have a DONE or FINISHED button.

It is an ergonomic mess, compounding the misunderstanding of the correct sequence in the documentation. How could this have happened? A good question. The same documents used by LNER to develop its training course and its driver operating instructions were also used both by the company developing the Class 800 full-cab driving simulator for LNER and the company commissioned by Hitachi to develop the app replicating the behaviour of the TMS.

Both simulator and app model incorporated the mistaken understanding of the role of the CHECK STOPS button. With both, the TMS accepted the changed headcode when the HOME button was pressed, which was not the case with the real train.

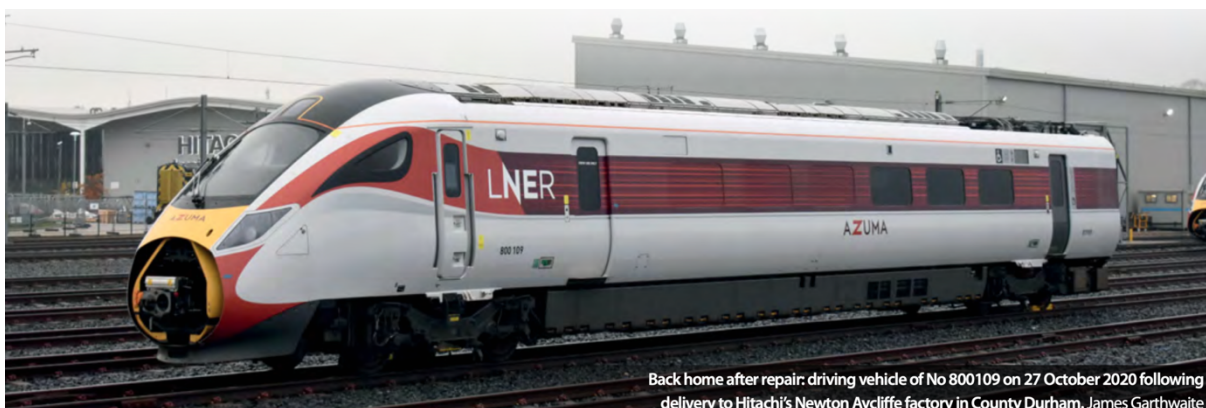
Back home after repair: driving vehicle of No 800109 on 27 October 2020 following delivery to Hitachi's Newton Aycliffe factory in County Durham. James Garthwaite
