Ladbroke Grove Rail Accident

Exercise

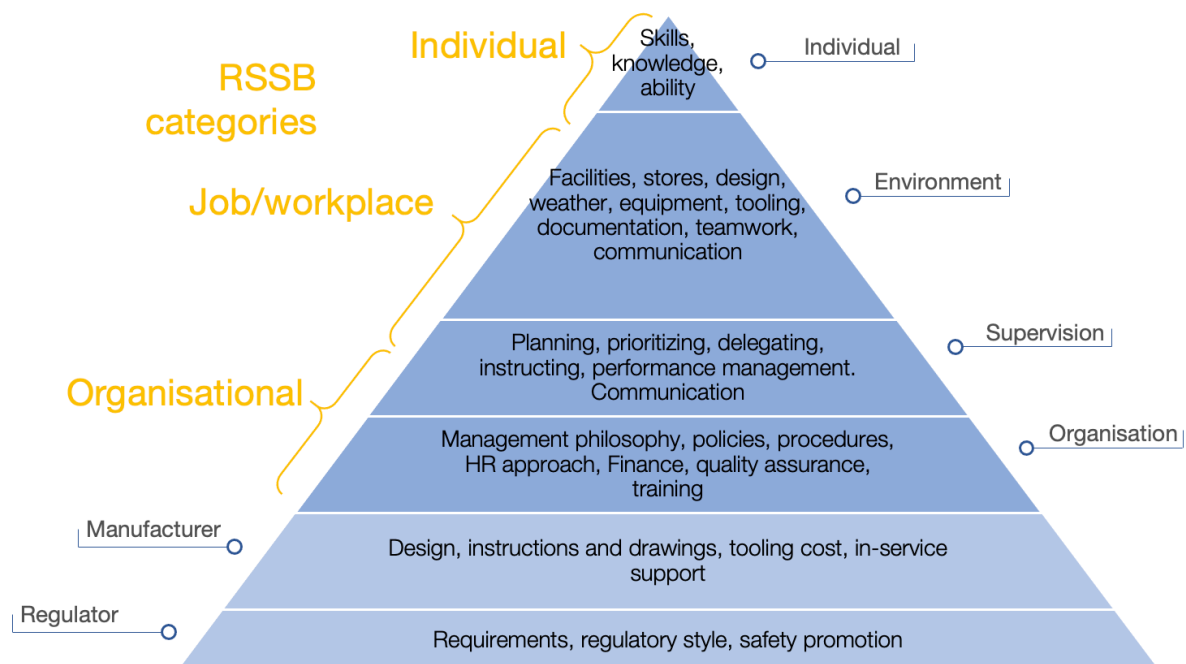
Read through the following contributory causes and place the factors in the system of influence:

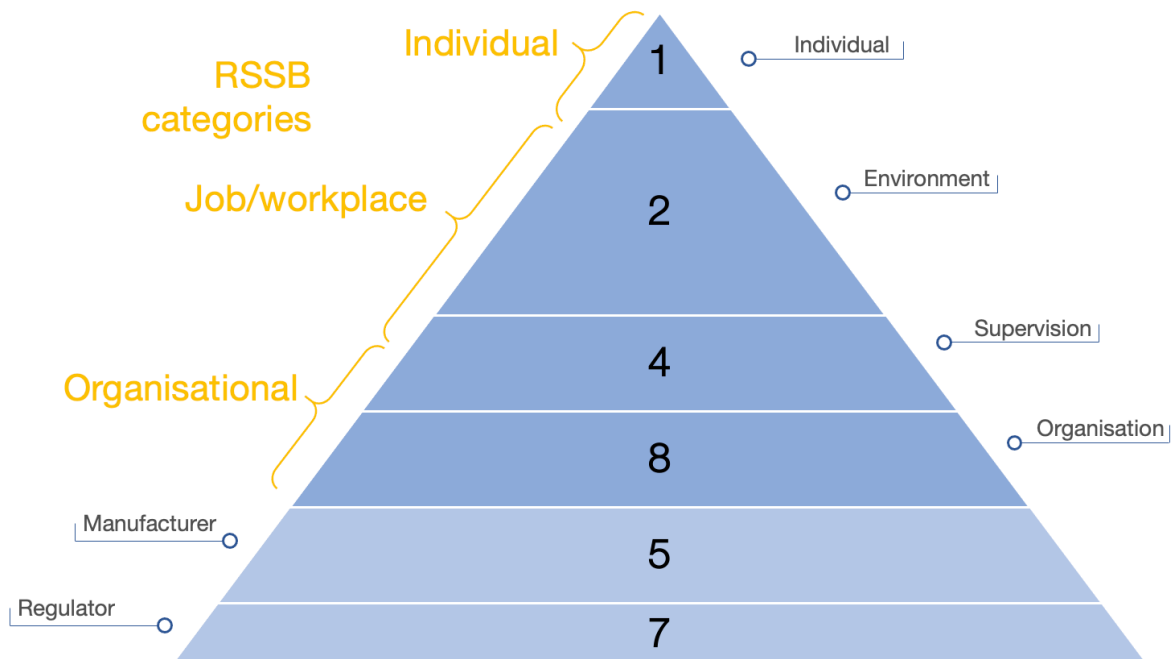
Worked example of causal factors – highlights that sometimes the scope of the investigation will not reach far enough. The trained professional investigator will always limit investigation to the facts presented to deliver the scope required. One might note wider issues.
